CONSERVATION MANAGEMENT PLAN

FOR THE EUSTON COURTHOUSE 39 MURRAY TERRACE, EUSTON

AUGUST 2024

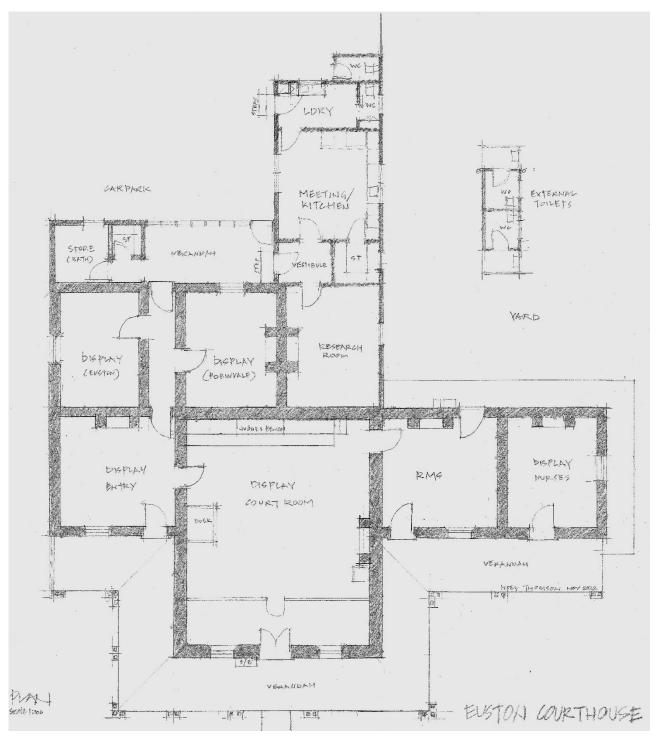
Fig 5: Existing Conditions Plan - Noel Thomson Architecture 2022

The condition of the building is fair with some signs of movement evident with cracking throughout the building and the southern end with evidence of 'rising damp' at internal and external wall areas.

Structure stability & condition: The wall structure should be stable and structurally sound, however in several locations throughout the building deterioration (rising damp, blistering of paint & drumminess to plaster, etc) and movement/cracking are evident that require attention.

Note: Rising Damp and surface deterioration of bricks and render evident to walls in several locations – treatment required to address dampness; see "Salt Attack and Rising Damp" extract explaining rising damp below - refer Fig 6 and Appendix 5 for the complete technical guide.

Note: Cracking currently to brickwork / walls in several locations - repairs and monitoring required, with action for rectification either structural underpinning of footings or structural expanding resin injection under footings to stabilise the walls and restrict ongoing movement.

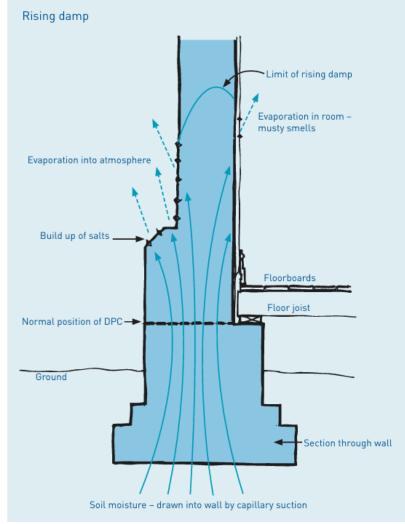
Fig 6: "Salt Attack and Rising Damp" – Technical Guide extract

Figure 6 Section through a solid wall showing the path of rising damp which is caused by the suction of porous masonry. The pores effectively form a network of capillaries which draw soil moisture against gravity. Damp rises in the wall and eventually evaporates from the wall surfaces. As well as damaging masonry materials, the dampness may lead to fungal rot and insects (borers and termites) in the floor timbers. Today it is normal building practice to include a moisture barrier known as a damp-proof course (DPC) across the base of the wall below all floor timbers and at least 150 mm above ground level
