# Murray and Sunraysia – Algae Alert Status

10 September 2026

This Blue-green algal (BGA) alert report is based on routine monitoring at sites in the Murray & Sunraysia Algae Reporting Area. The sites are monitored by WaterNSW and local water authorities. Satellite imagery may be used to supplement the monitoring data.

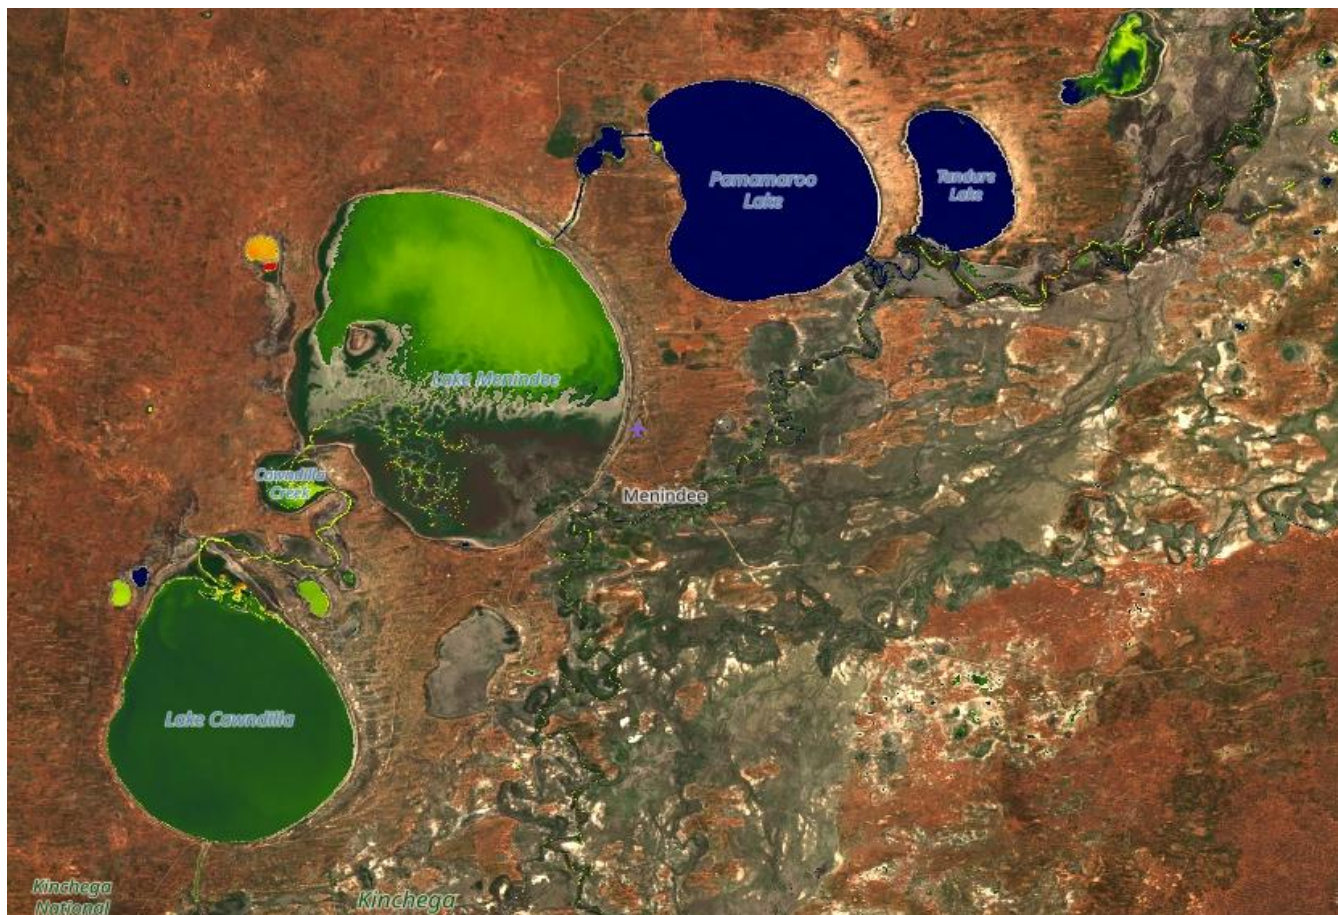
**Menindee Lake System** (Figure 2) - The image from the 30<sup>th</sup> of August indicates mostly low levels of algal activity across Lake Menindee, Lake Cawndilla, Weir 32 and Lake Wetherell site 1. Moderate levels were indicated at Cawndilla Creek. Mostly very low levels were indicated at Lakes Tandure, Pamamaroo, Copi Hollow and Wetherell sites 2, 3 & 4. Increased algal activity is present in areas of the Darling River between Lake Wetherell sites 3 and 4.

Figure 2: Menindee Lakes 30/08/2026 SentinelHub [CC BY-NC 4.0] NSW-RACC Custom Algae Script - TF, WaterNSW.
