CONSERVATION MANAGEMENT PLAN

FOR THE EUSTON COURTHOUSE 39 MURRAY TERRACE, EUSTON

AUGUST 2024

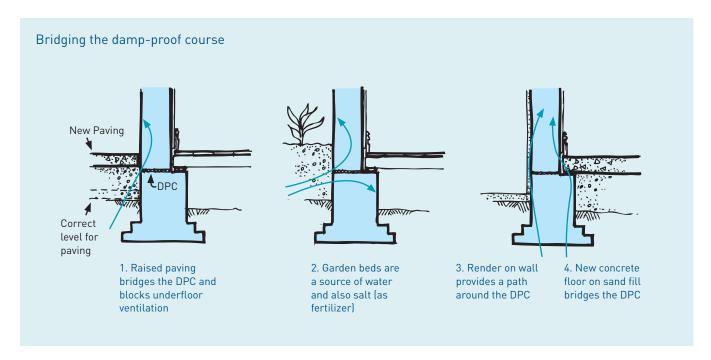
Rising damp is often caused by bridging the damp-proof course: a moisture pathway or bridge that negates the effect of the DPC. Bridges may be caused by rendering or plastering over the DPC. Pointing over the external face of a DPC will also cause a bridge, though it is important to be aware that asphalt or tar-based DPCs were often specified to be pointed over in hard cement, so as to retain the viscous DPC while minimising permeability. Examples where this pointing has failed are common, with the DPC extruding slightly from the joint (Figure 8). Poorly installed DPCs that do not form a barrier across the entire wall thickness will be bridged by mortar in the joints or cavity. Concrete floors or external paths can form a bridge if the concrete, or the fill beneath, abuts the DPC without some form of vertical damp-proofing. Build-up of garden beds and pavements against walls can also bridge the DPC (Figure 11). To be effective a DPC needs to remain about 200 mm above ground or paving level.

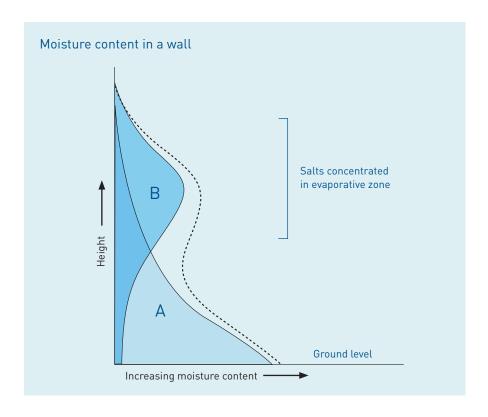
Figure 12 Moisture content in a masonry wall due to A, capillary action (rising damp) and B, hygroscopic salts. The total moisture content is shown by the dashed line and is the sum of A and B. The relative contributions of A and B to the total will depend on the amount and nature of the salts in the soils beneath, on the climate (humidity, temperature and wind speed) and on time (the older the wall the longer it will have had to accumulate salt).

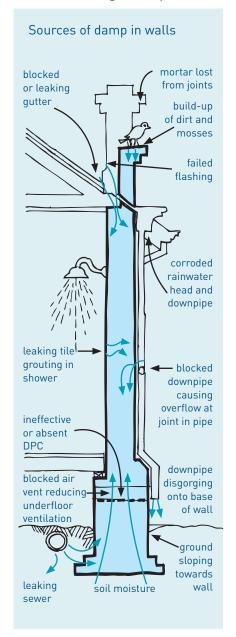
Figure 13 (above) The many sources of damp in walls.

Figure 14 (right) Two examples of falling damp. Overflow from the blocked rainwater head is made apparent by dark green algae. The coping above the rainwater head is allowing water through to the stones below. Salt attack is causing these stones, above and to the left of the rainwater head, to decay.

The typical debris that builds up in roof gutters and on parapets (such as fallen leaves, bird manure, mosses and dirt) contains weak acids which will contribute to masonry decay by slowly dissolving weaker components leading to progressively more porous and permeable materials. Salts also accumulate on the tops of buildings, not only near the coast, where sea spray is a major factor, but even in central Australia, where wind storms whip up salts from the dry salt lakes and where tiny particles of salt rain from the sky. Though the rates of accumulation of air-borne salt are relatively low, with time a building can absorb sufficient salt to cause damage, particularly when it is all concentrated at one point, such as the top of a blocked downpipe or rainwater head. The importance of regular maintenance of gutters and downpipes cannot be over-emphasised (Figure 14).

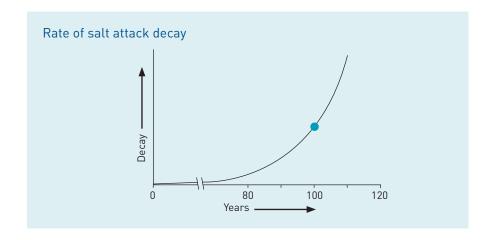
Figure 17 The rate of salt attack decay follows an exponential curve in which there is a long period of little or no decay as salt slowly accumulates in the pores of the masonry. Then when the salt has filled the pores there is a rapid acceleration of decay — the condition of a 100 year old building may be twice as bad after only another 10 years.
