Murray and Sunraysia – Algae Alert Status

9 May 2025

Murray and Sunraysia Regional Algal Coordinating Committee Blue- Green Algae Report

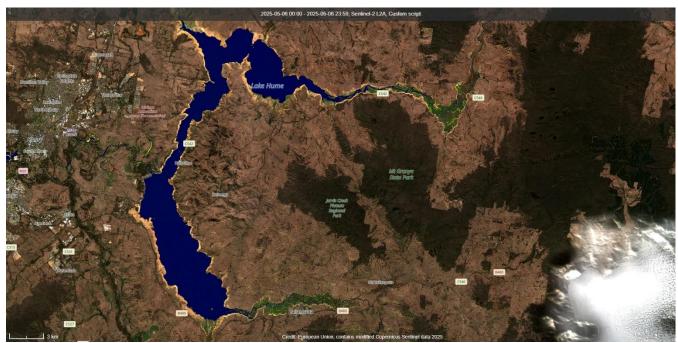
Figure 1 indicates that Hume Dam had mostly very low-level phytoplankton activity on 06/05/2025.

Figure 1: Hume Dam 06/05/2025 SentinelHub [CC BY-NC 4.0] NSW-Custom Algae Script - TF, WaterNSW.

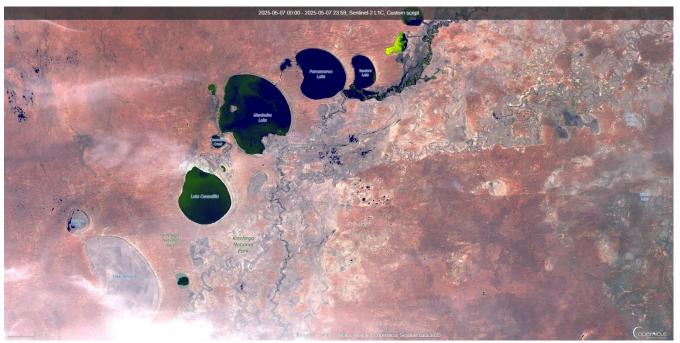
The satellite image of the Menindee Lakes on 07/05/2025 (Figure 2) indicates that Pamamaroo and Copi Hollow had very low phytoplankton activity. Lakes Tandure, Menindee and Cawndilla had very low to low phytoplankton activity. Very low phytoplankton activity was noted at lake Wetherell sites 4 and 3 as well as the Weir 32 weir pool.

Figure 2: Menindee Lakes 07/05/2025 SentinelHub [CC BY-NC 4.0] NSW-Custom Algae Script - TF, WaterNSW.

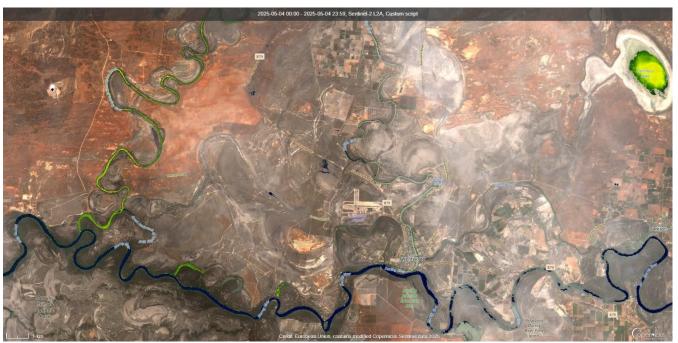
Figure 3 indicates that the Murray River near Wentworth had very low phytoplankton activity on 04/05/2025, while the anabranch had low to medium phytoplankton activity. The Darling River branch had mostly very low phytoplankton activity. The latest image, on 07/05/2025, is obscured by cloud cover.

Figure 3: Murray River near Wentworth, Lower Darling River and Great Darling Anabranch 04/05/2025 SentinelHub [CC BY-NC 4.0] NSW-Custom Algae Script - TF, WaterNSW.

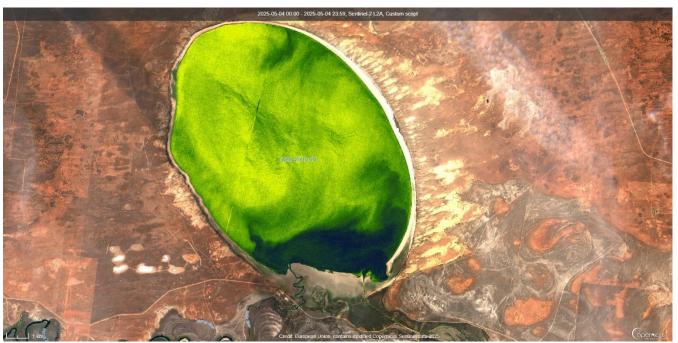
Lake Victoria had very low to medium phytoplankton activity on 04/05/2025 (Figure 4). The Murray River downstream of the Lake Victoria outflow had very low to low phytoplankton activity. The later image, on 07/05/2025, shows extensive cloud cover.

Figure 4: Lake Victoria 04/05/2025 SentinelHub [CC BY-NC 4.0] NSW-Custom Algae Script - TF, WaterNSW.

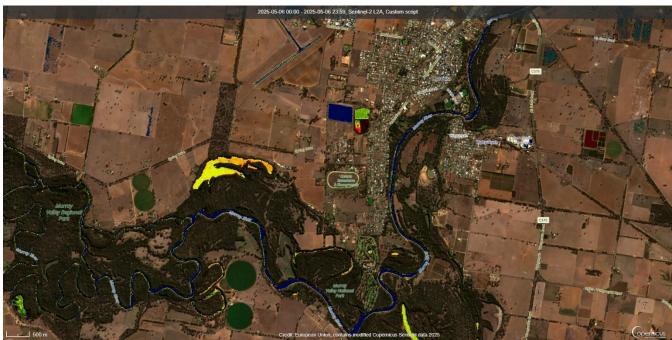
The Murray River at Corowa (Figure 5) had very low phytoplankton activity on 06/05/2025.

Figure 5: Murray River at Corowa 06/05/2025 SentinelHub [CC BY-NC 4.0] NSW-Custom Algae Script - TF, WaterNSW.

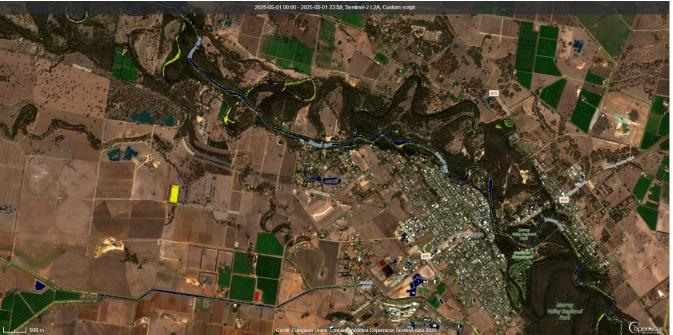
The Edward River at Deniliquin (Figure 6) had very low phytoplankton activity on 01/05/2025

Figure 6: Edward River at Deniliquin 01/05/2025 SentinelHub [CC BY-NC 4.0] NSW-Custom Algae Script - TF, WaterNSW.

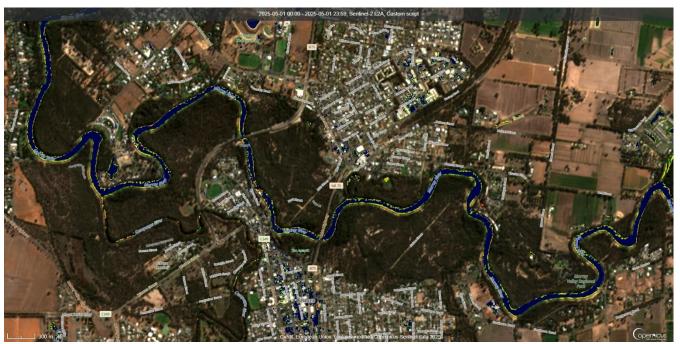
Figure 7 shows the Murray River at Moama on 01/05/2025. Very low phytoplankton activity was noted on the image.

Figure 7: Murray River at Moama 01/05/2025 SentinelHub [CC BY-NC 4.0] NSW-Custom Algae Script - TF, WaterNSW.

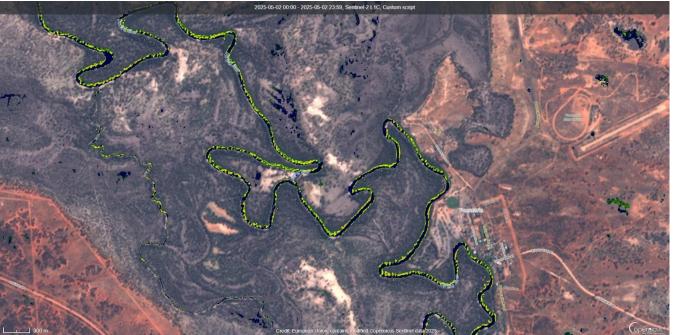
Figure 8, the Darling River at Pooncarie, showed mostly very low phytoplankton activity on 02/05/2025.

Figure 8: Darling River at Pooncarie 02/05/2025 SentinelHub [CC BY-NC 4.0] NSW-Custom Algae Script - TF, WaterNSW.
