Murray and Sunraysia – Algae Alert Status

8 January 2026

This Blue-green algal (BGA) alert report is based on routine monitoring at sites in the Murray & Sunraysia Algae Reporting Area. The sites are monitored by WaterNSW and local water authorities. Satellite imagery may be used to supplement the monitoring data.

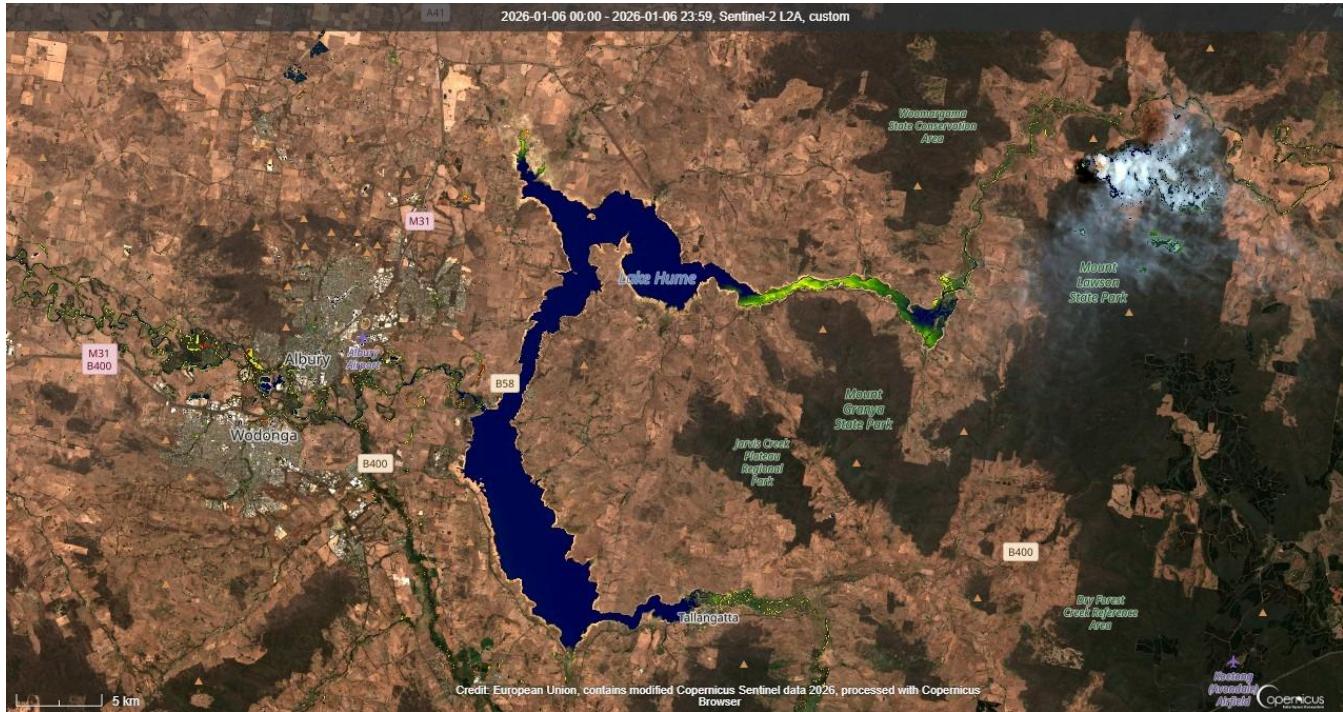
Figure 1 indicates that Hume Dam had mostly very low-level phytoplankton activity on the 6th of January, with medium levels indicated in the Murray River arm near Wymah. Smoke from the Shire of Towong bushfire can be seen in the upper right corner of the image.

Figure 1: Hume Dam 06/01/2026 SentinelHub [CC BY-NC 4.0] NSW- RACC Custom Algae Script - TF, WaterNSW.

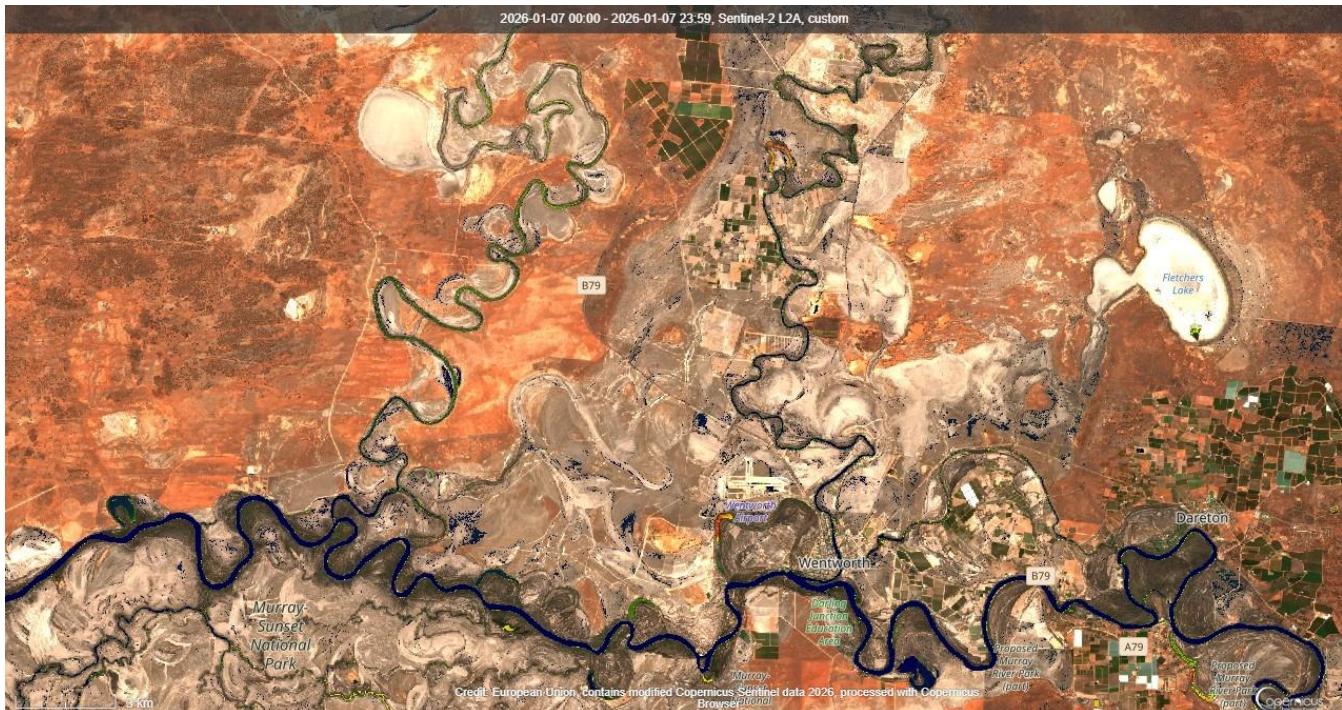
On the 7th of January, the Murray and Darling Rivers near Wentworth indicated mostly very low levels of algal activity (Figure 3).

Figure 3: Murray River near Wentworth, Lower Darling River and Great Darling Anabranch 07/01/2026 SentinelHub [CC BY-NC 4.0] NSW- RACC Custom Algae Script - TF, WaterNSW.

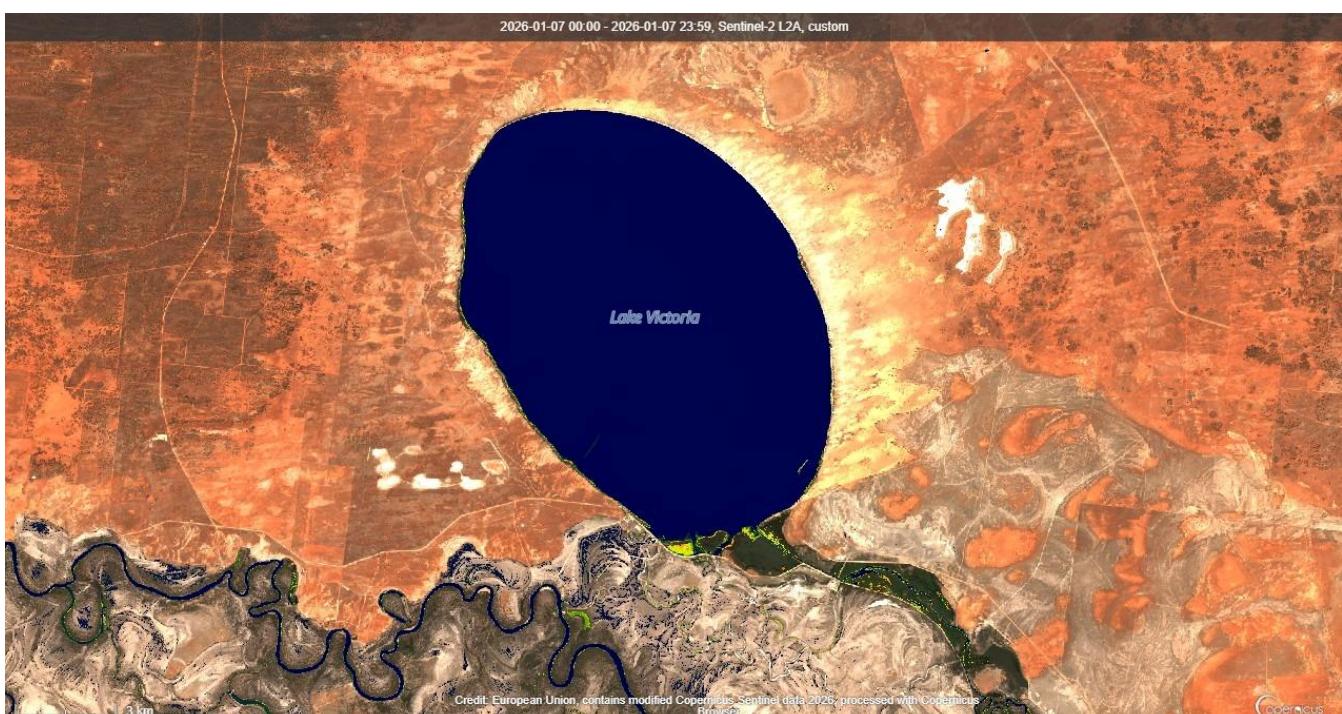
Lake Victoria showed mostly very low phytoplankton activity on the 7th of January (Figure 4).

Figure 4: Lake Victoria 07/01/2026 SentinelHub [CC BY-NC 4.0] NSW- RACC Custom Algae Script - TF, WaterNSW.
